THAILAND FLOODS 2011

THE NEED FOR HOLISTIC FLOOD RISK MANAGEMENT

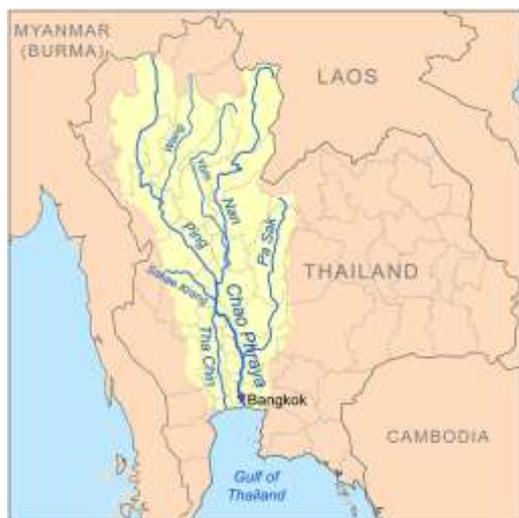
Figure 1. The Chao Phraya River Basin

The Chao Phraya River Basin (Fig. 1) has an area of 162,000km² and a length of approximately 700km. The Chao Phraya Basin is mountainous in the upper region, while the lower region is a highly productive flat alluvial plain intensively used for agriculture. The surface elevation of the flood plain is a few metres above mean sea level with an overall gradient towards the Gulf of Thailand of appr. 1.5m per 100km.

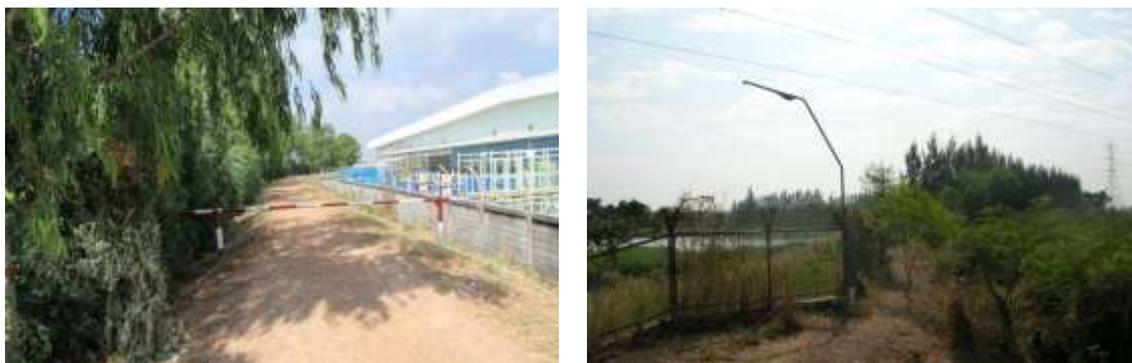
Figure 2. Examples of sound and unsound implementations of flood embankments in Rojana and Hi-Tech Industrial Estates (Source: DHI, previous studies)

- **Preparedness and protection**
In the Chao Phraya Basin, flood mitigation strategies include both structural (e.g. dykes, storage areas) and non-structural measures (diversion schemes and flood retarding areas). However, in many cases structural solutions failed: Flood walls broke after a prolonged flood period in many areas including the ancient city of Ayutthaya, some Industrial Estates, others are about to break even in the Bangkok areas. For example, part of the embankment of the Hi Tech Industrial Estate located north of Bangkok broke due to leaking failure weakening its structure. Moreover, the emergency reinforcement failed (The Bangkok Post, 2011). In previous site investigations DHI warned that none of the five investigated Industrial Estates plains would be able to face a 50Y flood event due to too low structure crest (e.g. Rojana IE) or unsound engineering design and maintenance (e.g. Hi-Tech IE).
